GPR AS A TOOL FOR DETECTING PROBLEMS IN HIGHWAY-RELATED CONSTRUCTION AND MAINTENANCE

J. Scott Lewis*, William P. Owen+, and Charles Narwold+

California Department of Transportation,

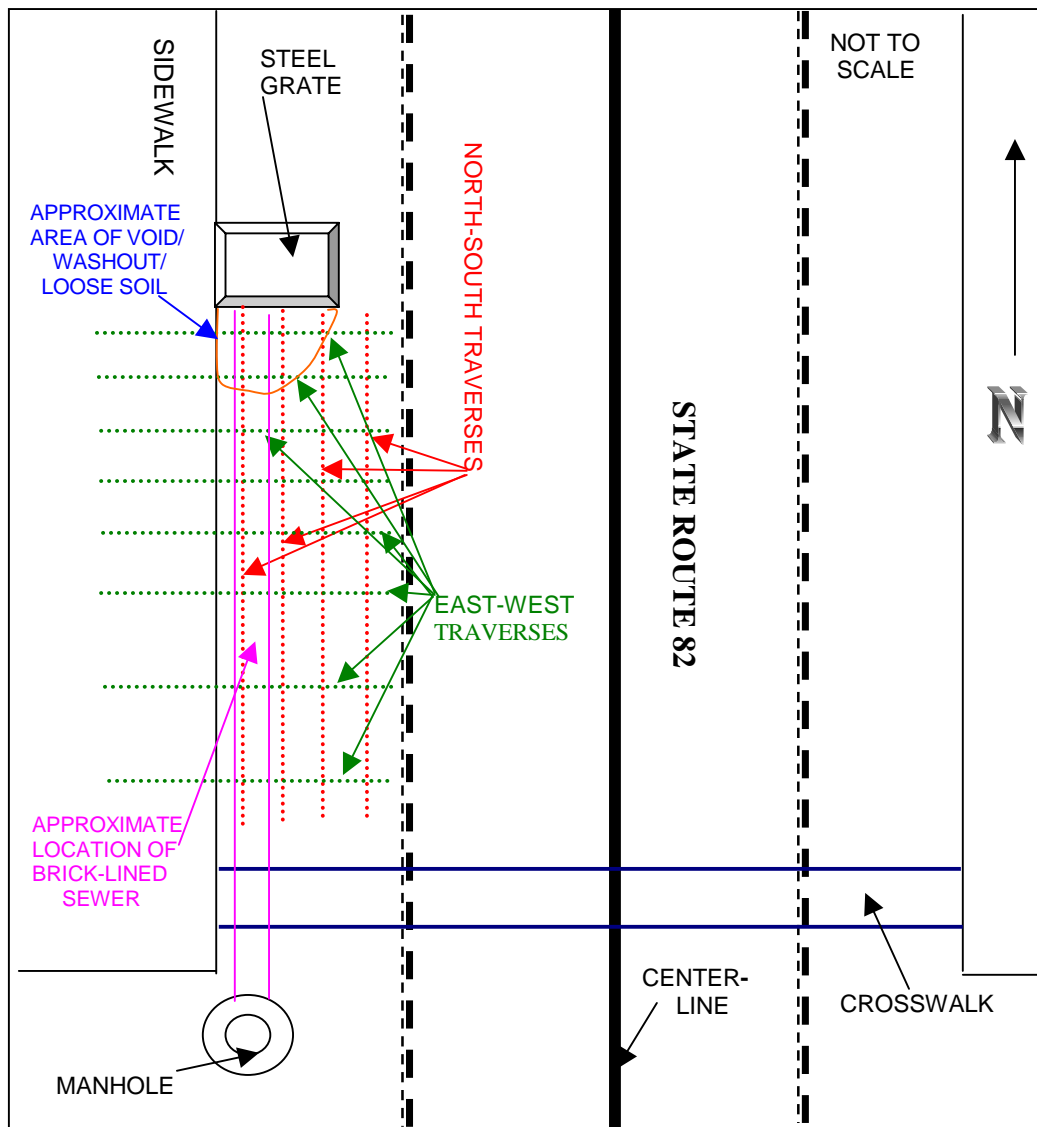
Figure 1. Location map for void/washout & brick-lined sewer investigation on State Route 82 in Burlingame. Map shows approximate location of GPR traverses, steel grate, imaged brick-lined sewer, and void/washout/loose soil area.

The presence of void space beneath the pavement, apparently produced by leakage from an old north-south sewage conduit, is confined to an area from 0.0 to 2.5 meters south of the steel grate that extends from just below the lip of the curb to almost 1 meter from the curb. No evidence of leakage-

produced void space exists anywhere else in the radar records. It is quite possible that leakage has occurred over time along the sewer and caused a gradual subsidence of the gutter and sidewalk edge, but no evidence of voids or loose material is found along it now, except near the steel grate. The sewer is located about 0.6 meters from the curb.
